Basement Wall Cracking

The Important Parts of a Good Foundation Wall

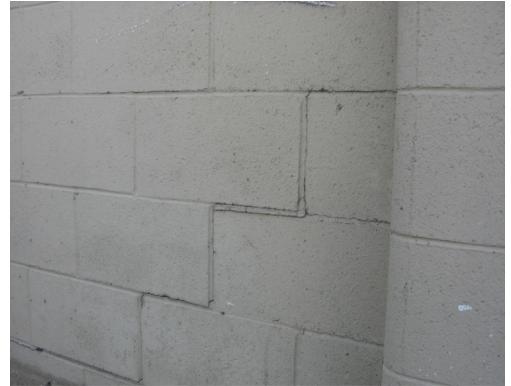
- One common type of cracking is sometimes referred to as "Stair Step" cracking. This is a diagonal zig-zag pattern that quite often follows the mortar joints. This type of cracking is usually the result of uneven settlement on either side of the crack.

Typical "Stair Step" Cracking

As mentioned above, this cracking is most likely the result of differential or uneven settlements of the footing and subgrade below the wall. This might be due to a change in loading on the wall or a soft spot in the soil below the footing. The first question to try to resolve is whether the wall is still moving or not. This can be done by monitoring the condition. This takes some time but since this type of crack is usually not a serious threat, time is available to record some data.

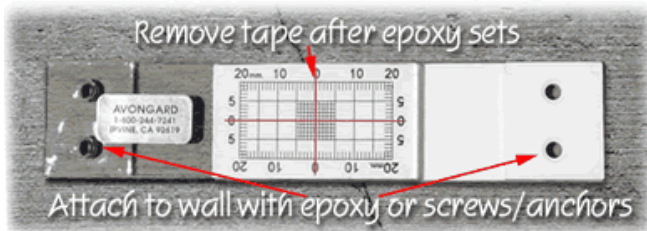
Crack monitors are available from several companies, one is Avongard (www.avongard.com). These are attached across the crack and have a grid and crosshair that allow you to measure movements to within 1 mm. Record this information at the initial installation and each following month using the data sheet provided with the crack monitor. It never hurts to keep taking photos.

Example from the Avongard website

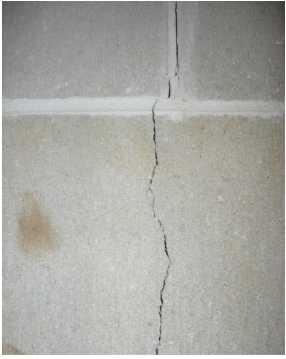
- Another common crack is a vertical crack. This crack may not be perfectly vertical and may do some "stair stepping" of its own, but the crack usually passes through masonry units instead of following only the mortar joints and proceeds in a mostly vertical direction. This type of cracking is quite often the result of shrinkage and thermal movements of the wall.

Typical vertical cracking

This type of cracking is often due to shrinkage of the masonry or concrete as it dries out or movements due to changes in the temperature of the wall. Block and concrete are constructed in a very wet condition. Water is present in the concrete, the mortar and the grout. The free water, the water that is not required to create the chemical bond in the Portland cement, eventually has to evaporate out of the wall. This evaporation occurs during the curing process and the loss of water will cause a slight loss of volume. The wall wants to shrink to compensate for this loss. Every other part of the building is trying to hold the wall in a rigid position and prevent it from actually shrinking. So rather than shrink from the ends, the wall will develop cracks along its length. A well designed wall will actually develop hundreds of microscopic cracks along its entire length that will compensate for the shrinkage. Sometimes, however the wall will find a weak plane and decide to make up all of the shrinkage at one location. It seems inevitable that the wall will choose the most noticeable and objectionable spot to produce the new crack.

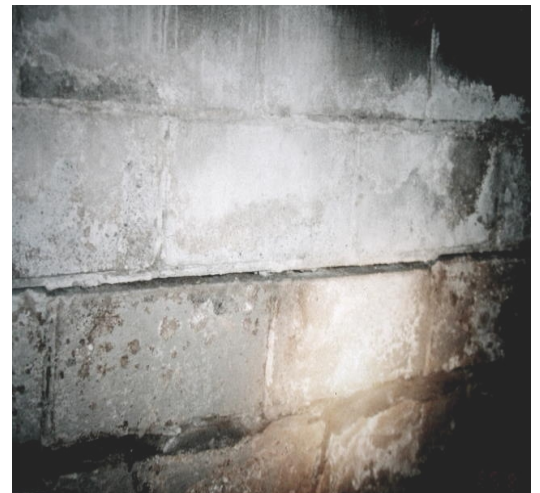
- The other type of cracking, and the one that we structural engineers become quite concerned about, is a horizontal crack. This crack usually occurs near the midheight of the wall. Along with the cracking, the wall usually exhibits measurable inward bowing. This type of crack is the result of lateral soil loads pushing against the wall that exceed the strength of the block or concrete.

Example of a horizontal crack

The crack is evidence of horizontal movement and inward bowing of the wall. The soil on the outside is pushing the wall and the wall does not have enough strength to resist this movement. It is possible that the wall was not designed properly, but it is also possible that the forces are greater than a reasonable design might anticipate. If drainage is poor and the soil adjacent to the wall becomes saturated or if the winter is particularly severe, and frost penetration becomes severe, the force pushing against the wall may become extremely high. It is also possible that the movement took place during construction if the wall was not adequately braced during the backfilling procedure.

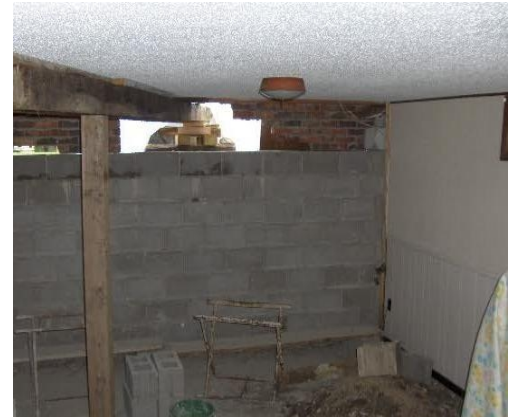
- A. Removal and reconstruction of the wall. This will be the most expensive solution, but it might be the repair that gives you the greatest piece of mind. The steps involved include; excavating to the footing level, shoring the floor(s) and roof that bear on the wall, wall demolition and reconstruction. The wall reconstruction should consider the forces that caused the original cracking and bowing and the wall should be designed to adequately resist these forces. A well designed wall will most likely include vertical reinforcing, anchoring to the footing and the floor above, drain tile, waterproofing or damproofing, and clean granular backfill. You will definitely want to work with a contractor who has done this type of work before.

One basement wall undergoing complete replacement

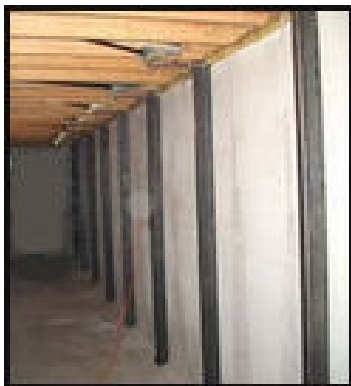
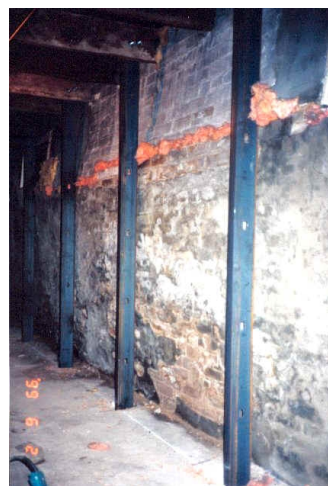
Some examples of bracing using steel members
